Post-Seismic Capacity of Damaged and Repaired Reinforced Concrete Plastic Hinges Extracted from a Real Building

2017 NZSEE
Conference

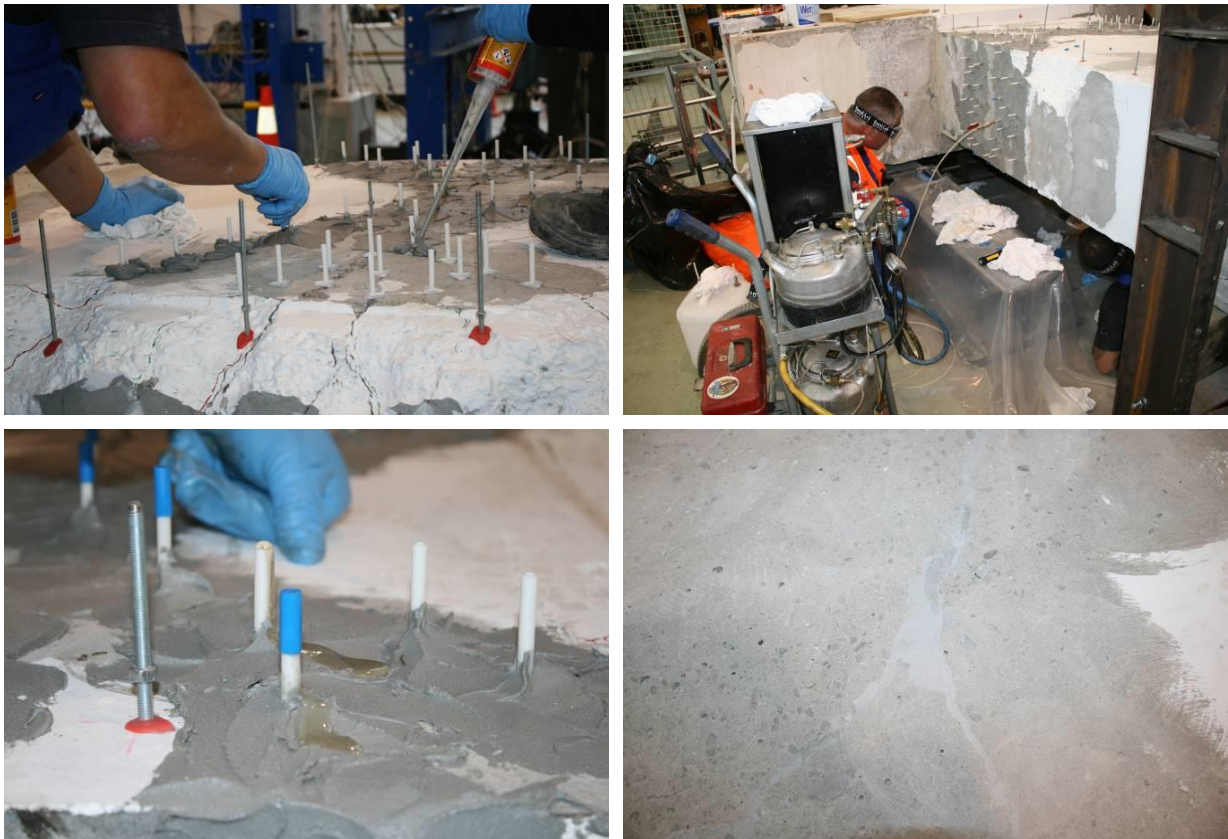
Figure 5. Epoxy repairs in specimen 3. Sealing process with epoxy mortar and installation of injection ports (upper-left); resin injection with an air-operated pump (upper-right); epoxy resin leaking from and sealing of the injection ports (lower-left); finish once the epoxy mortar has been removed (lower-right).

The repair works were conducted by BBR CONTECH, concrete specialists with broad experience on epoxy injection repairs in Christchurch following the CES, with the technical support from the product manufacturer. As shown in Figure 5, the damaged specimens were repaired in the same horizontal position as they were tested. The repair process started with grinding the surface along the crack lines to seal them with a well bonded epoxy mortar. It was necessary to seal both sides of the crack to prevent leakage. Injection ports were simultaneously installed at 100-200 mm crs. (sometimes closer depending on the cracking pattern). The epoxy material was mixed and the resin was injected under pressure via the injection ports through an air-operated pressure pump. The injection port was sequentially interchanged to allow the resin to travel and fill the interior cracks. The ports were sealed as the resin started leaking through them. Once the injection process was finished, the surface was cleaned off by removing the hardened epoxy mortar, leaving the surface flush. A total 4.8 L and 10.9 L of resin injected at 34.5 MPa (5 psi) were required to repair the specimens 2 and 3, respectively.

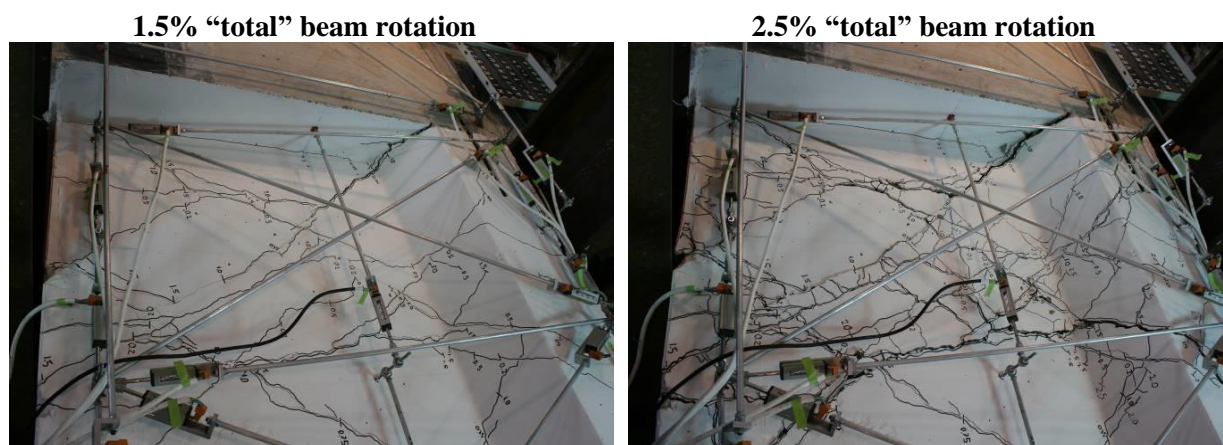
Cracks of 0.1mm in width opened up at 0.2% “total” beam rotation. These cracks might be pre-existing ones (earthquake induced) that closed due to the low level of inelastic action. At 1.5% total rotation most of the deformation was concentrated at a single diagonal crack 4-12 mm wide (see Figure 6), and shear distortions became more evident. The reason of these diagonal cracks could be excessive principal tensile stresses as a result of the diagonal compression strut induced by the hooked bars within the plastic hinge relocation detail. It was not possible to test the specimen up to failure due to the excessive and unexpected shear deformation (and sliding shear mechanism) of the specimen. The reaction frame was later modified in order to accommodate such displacement.

Figure 6. Residual racking pattern observed during Test 1, at 1.5% and 2.5% “total” beam rotation.

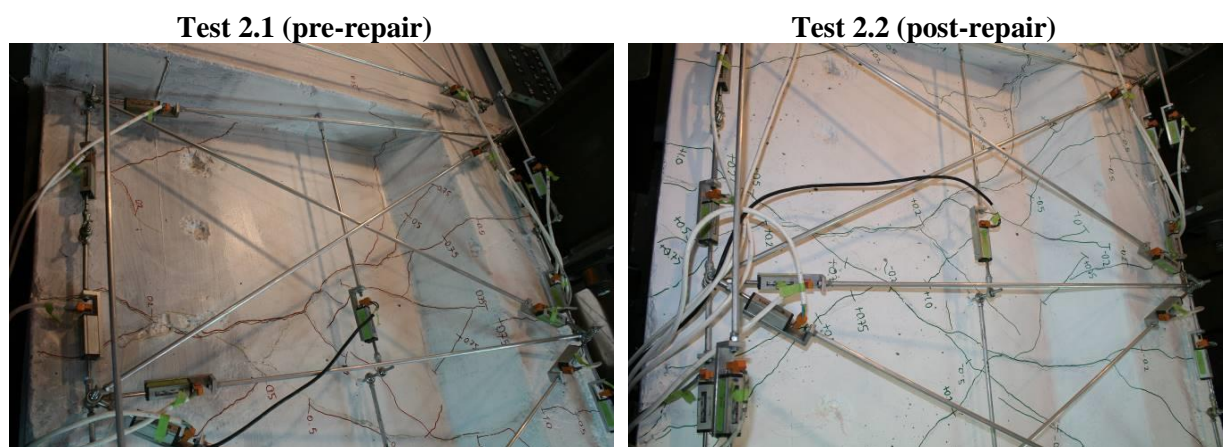
Cracks 0.1 mm wide were also observed at 0.2% “total” beam rotation. Maximum cracks of 3 mm in width were observed at 1% “total” beam rotation (see Figure 7). By comparing the cracking pattern before and after the test, it is believed that most of the (earthquake) pre-existing cracks were activated at this beam rotation level. Residual (static) cracks between 0.1 mm and 2.0 mm in width were observed at the end of the test.

Cracks of 0.1-0.2 mm in width started developing at 0.1% “total” beam rotation. A new crack extended from the column face towards the interior of the joint, and did not follow the injected crack path. At 0.75% “total” beam rotation, 0.1 mm-hairline cracks started developing outside the plastic hinge relocation detail. At beam rotations of 1.5%, residual (static) cracks started becoming comparable to the maximum observed (70-90% of the maximum crack width). Maximum cracks of 9-18 mm in width were observed at 2.5% “total” beam rotation. As shown in Figure 7, most of the repaired cracks re-opened up during the Test 2.2.

Figure 7. Residual cracking pattern observed during Test 2 at 1.0% “total” beam rotation.

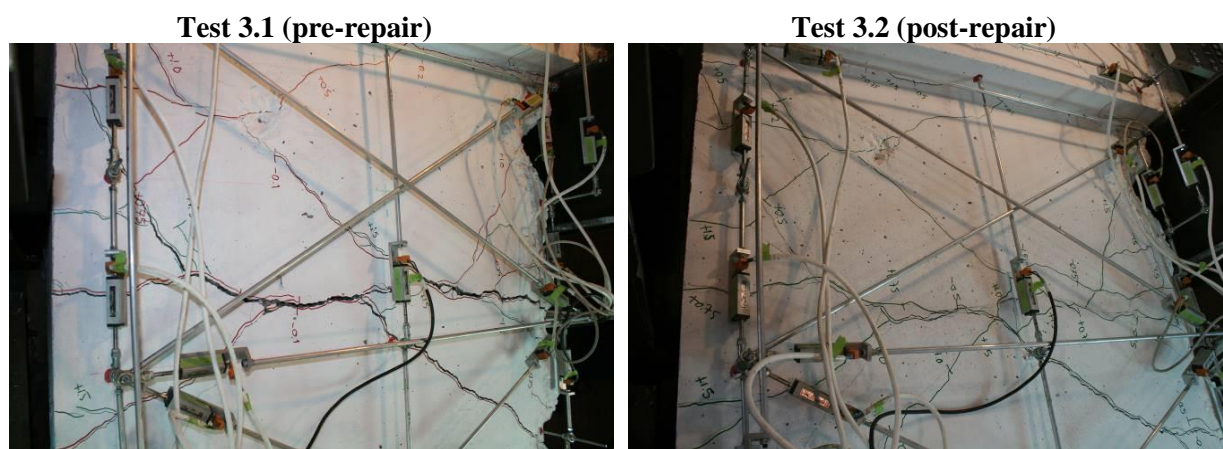
Cracks 0.1 mm wide were observed at 0.1% “total” beam rotation. Sliding and diagonal cracking was observed at the cold joint, even at such low rotation level. New flexural cracks were observed outside the plastic hinge relocation detail. As in the Test 3.1, residual (diagonal) cracks started becoming comparable to the maximum observed at 1.5% “total” beam rotation level. Maximum cracks of 10mm in width were observed at 2.5% beam rotation. As shown in Figure 8, most of the repaired cracks opened up during the Test 3.2.

Figure 8. Residual cracking pattern observed during Test 3 at 1.5% “total” beam rotation.

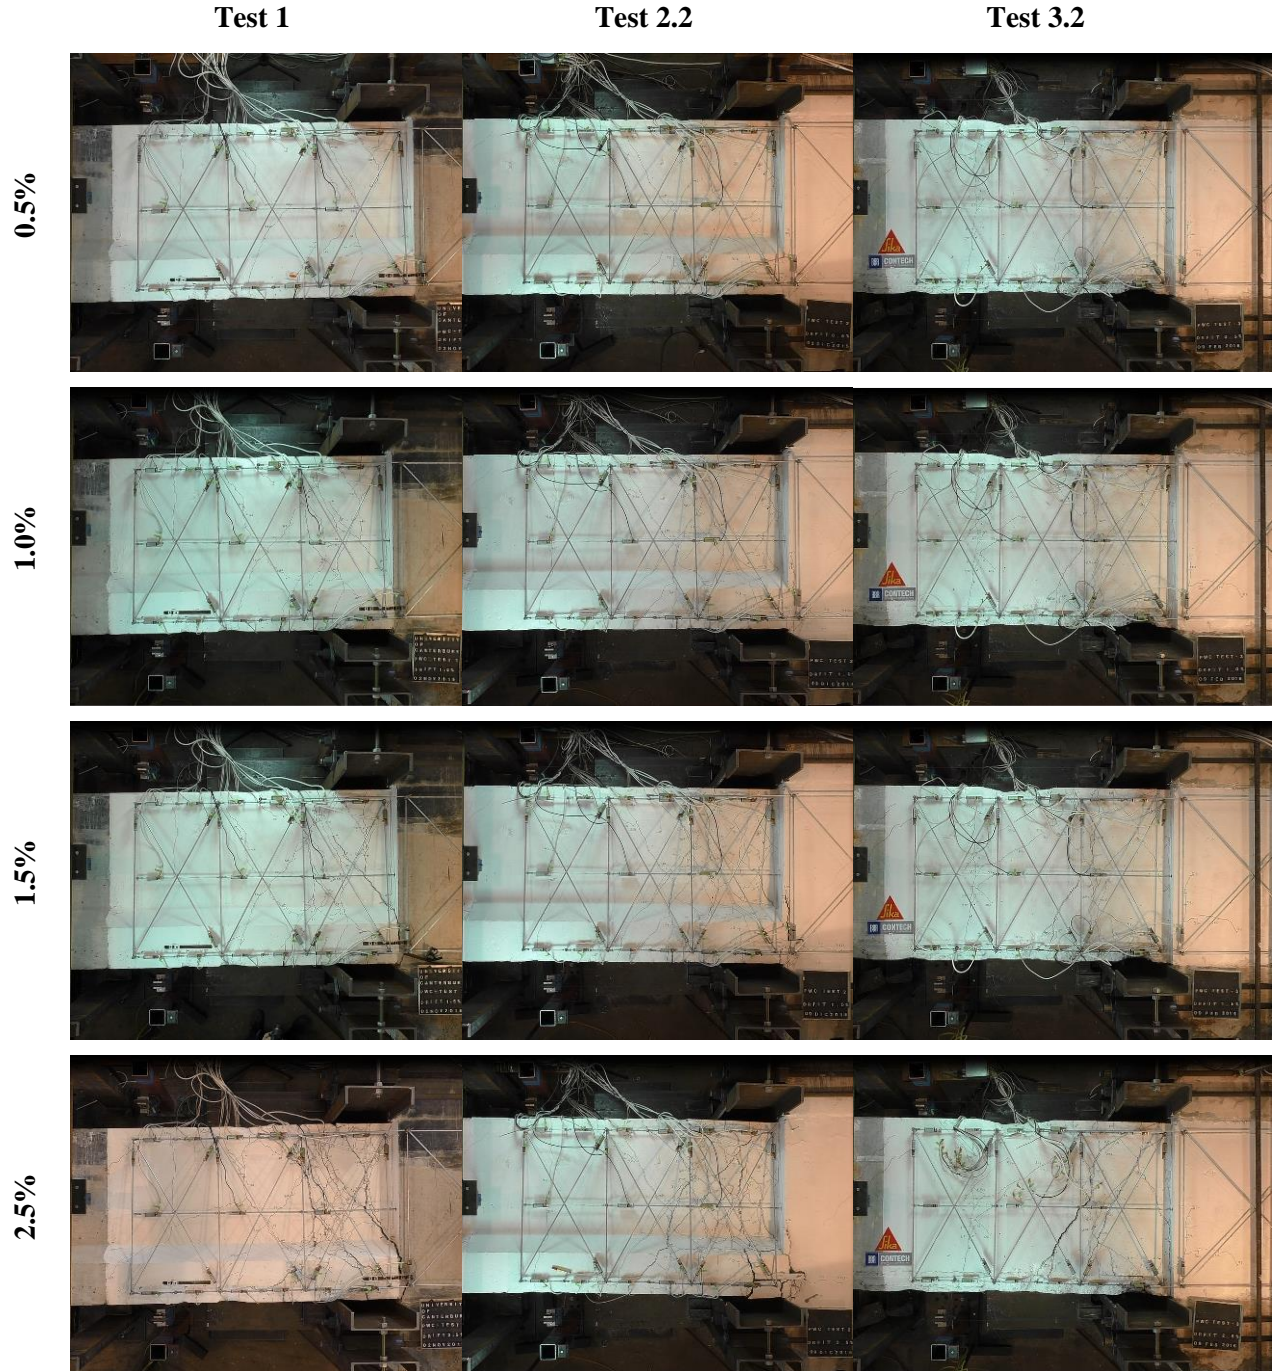
Figure 9 shows cracking patterns in Tests 1, 2.2 and 3.2, at different levels of “total” beam rotation. It is evident that the damage in Test 2.1 is more severe at lower (below 1.5%) rotation levels. Test 1

experienced the most severe damage at 2.5%, while Test 3.2 experienced the less damage at all rotation levels, with some of the damage in the form of flexural cracks outside the plastic hinge relocation detail.

Figure 9. Observed damaged at different beam rotations (in “total” displacement units).
